LOST LAKE DAM
LINCOLN COUNTY, MISSOURI
MO. 10212

**PHASE I INSPECTION REPORT
NATIONAL DAM SAFETY PROGRAM**

SEPTEMBER 1979

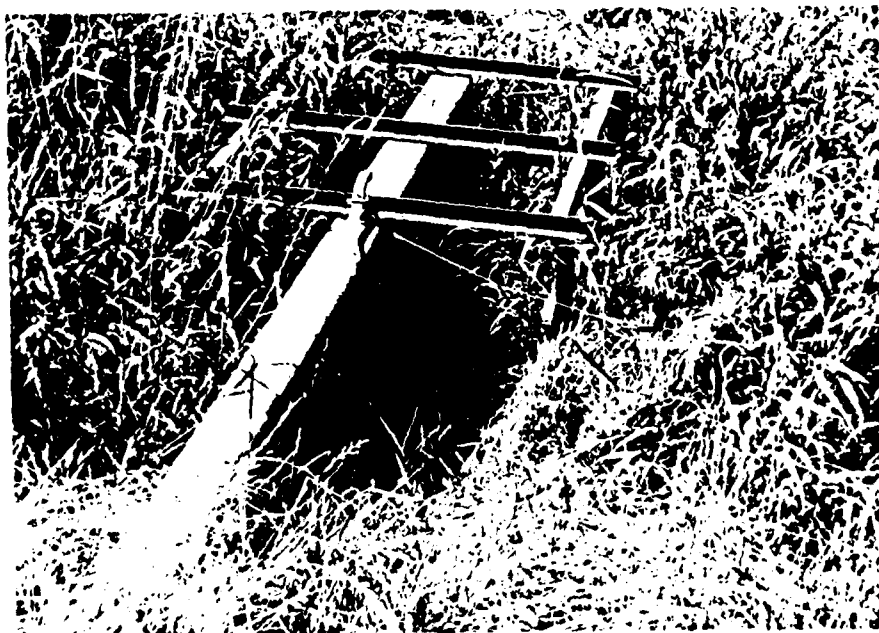
Photo 4

The tall grass around the intake to the principal spillway should be cleared and not allowed to grow back. This condition poses an obstacle to the normal operation of the principal spillway. The seepage through the conduit of the principal spillway does not jeopardize the safety of the embankment in its present condition, but it should be monitored for any changes in quantity and color.

- (a) Remove tall grass from around intake to the principal spillway and keep the grass from growing back.
- (b) Repair eroded area on the embankment near the crest at the left abutment and protect the area from further damage.

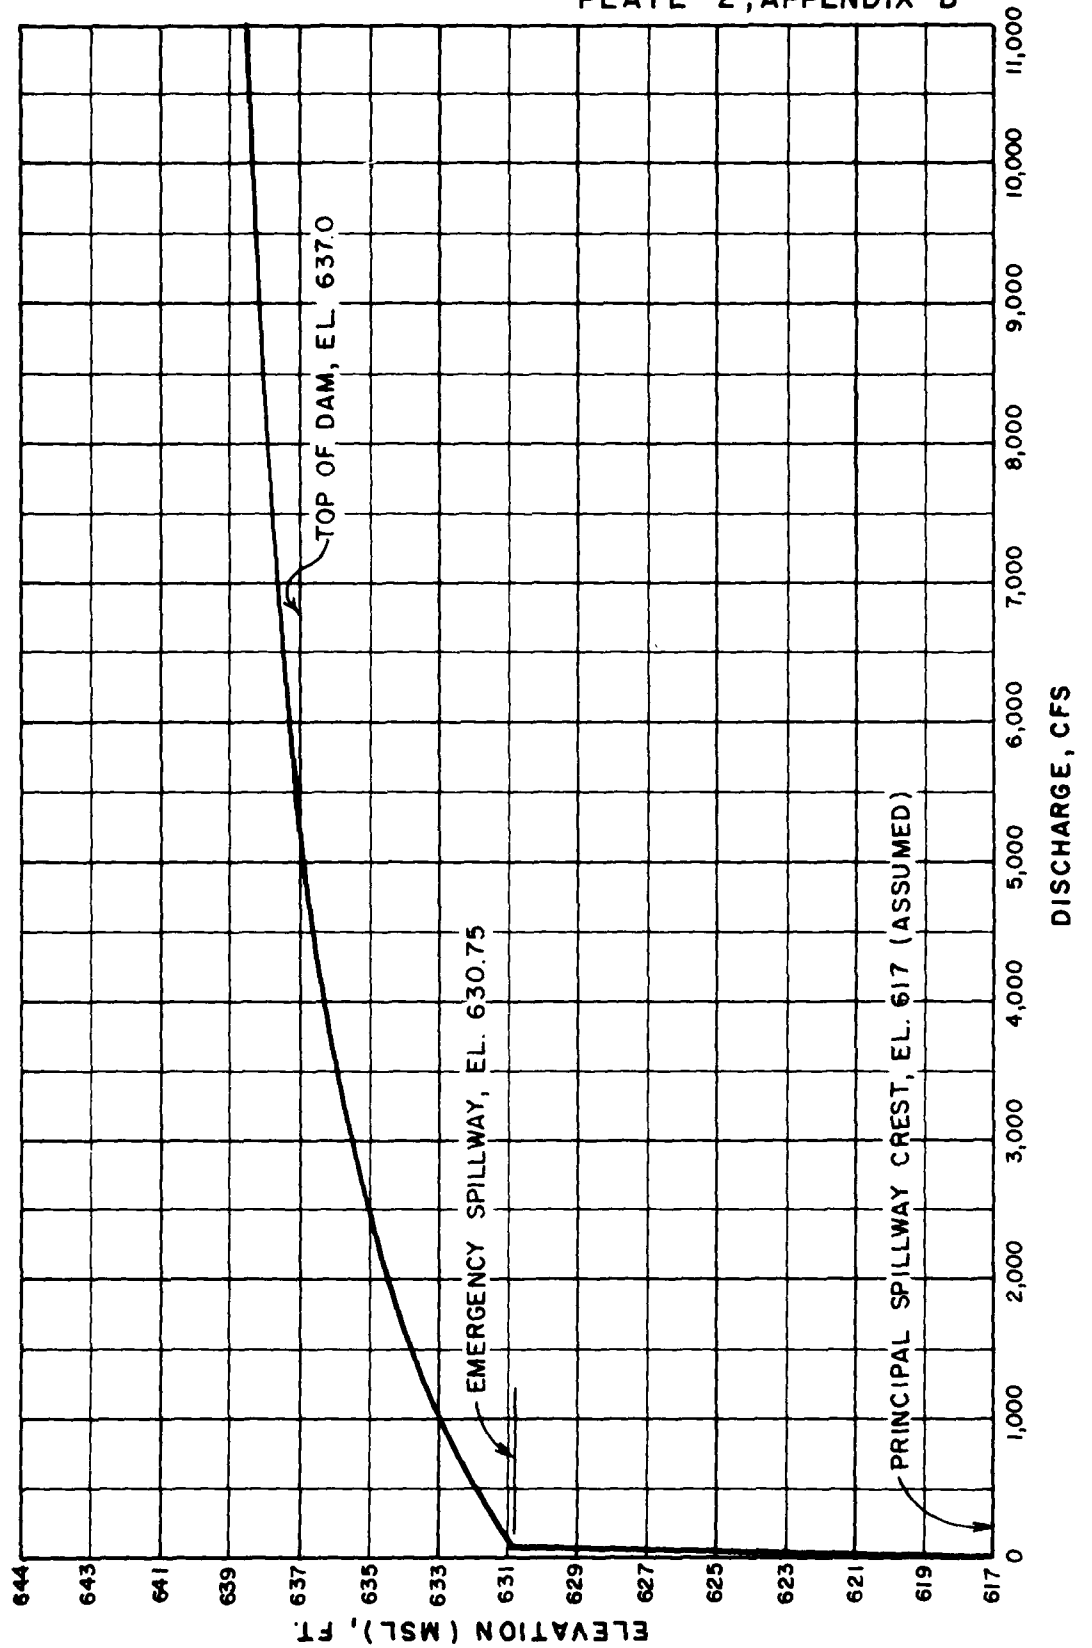
PLATE 2, APPENDIX B

The stage-outflow relation for the spillway was prepared from field notes and sketches prepared during the field inspection and limited design drawings. The reservoir stage-capacity data was based on the U.S.G.S. Luckett Ridge, Missouri Quadrangle topographic map (7.5 minute series). The spillway and overtop rating curve and the reservoir capacity curve are presented in Plates 2 & 3, respectively, in Appendix B.
